Ground-Based Thermographic Blade Inspection

Solving the Triple Constraints of Quality, Time and Costs

By Fabianna Tenorio and Jürgen Austen, Hensoldt, Germany

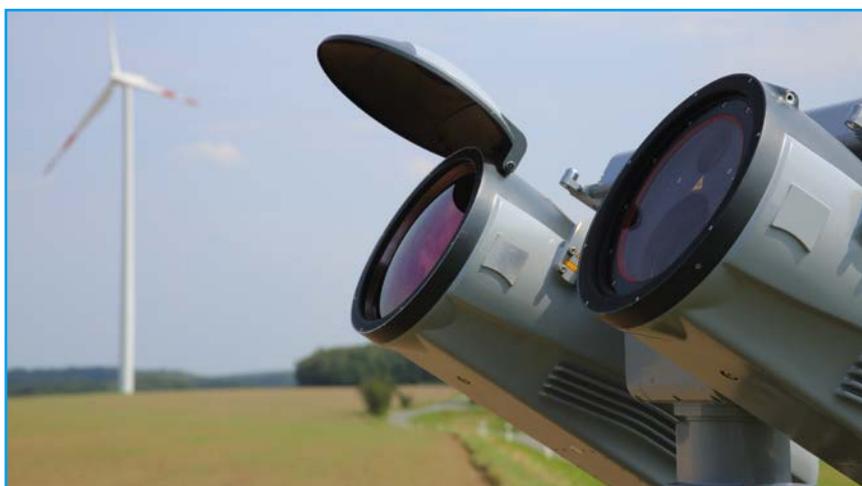
Figure 1. Thermographic technology now available for the wind blade inspection market

dual use goods, enabling the company to target new markets, such as the inspection of composites. Due to its cutting-edge thermography, laser technologies and over 40 years' experience in outdoor and offshore applications, Hensoldt has decided to enter into the market of wind blade inspections and provide a novel inspection service: high quality, fast and cost-efficient optical and thermographic inspection from the ground (Figure 1).
